**SENTINEL**  
INSPECTION GROUP

# PROPERTY INSPECTION REPORT FORM

Keesha Johnson <i>Name of Client</i>	03/22/2024 <i>Date of Inspection</i>
324 W Alabama St., Houston 77006 <i>Address of Inspected Property</i>	
Ruben Santillan <i>Name of Inspector</i>	5570 <i>TREC License #</i>
<i>Name of Sponsor (if applicable)</i>	<i>TREC License #</i>

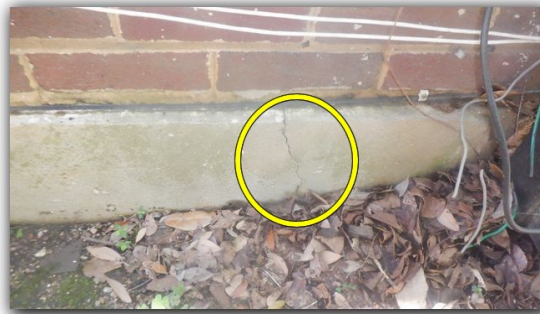
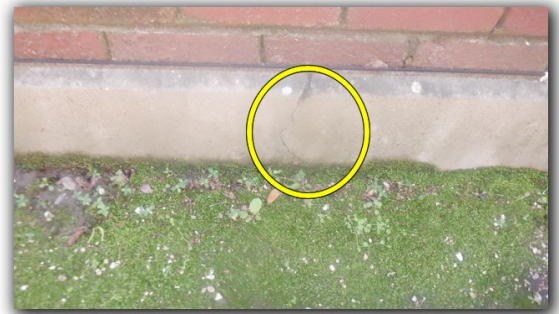
Foundation beam cracks observed on the west side at multiple locations.

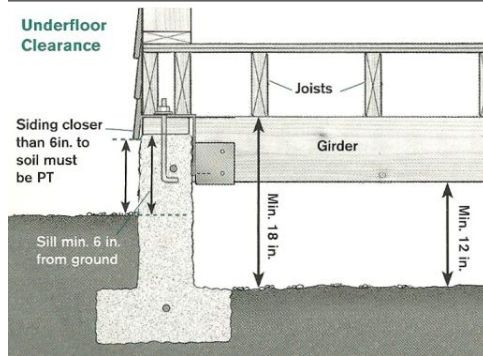
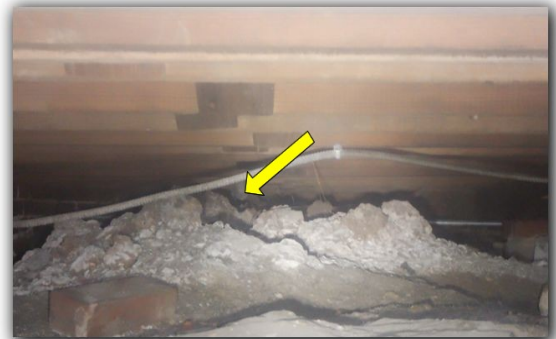
Observed wood framing under house has inadequate clearance from soil to prevent wood rot according to code. **Minimum soil clearance to untreated wood joists is 18".** **Minimum soil clearance to untreated wood beams is 12".** IRC R317.1

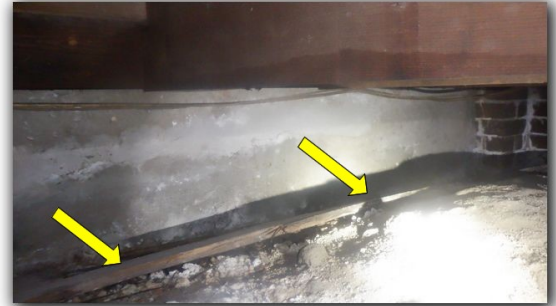
Scrap wood below house is considered a conducive condition for wood destroying insects.

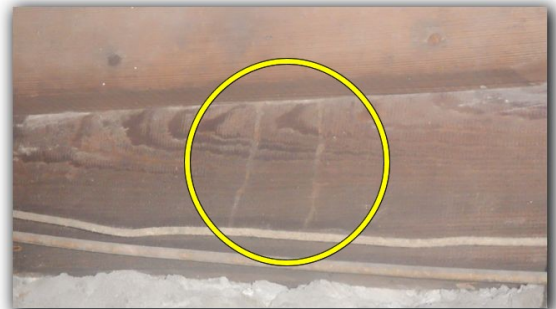
Multiple areas observed below house with various degrees of damage from wood destroying insects. No damage found was significant enough in my opinion as in need of repair.

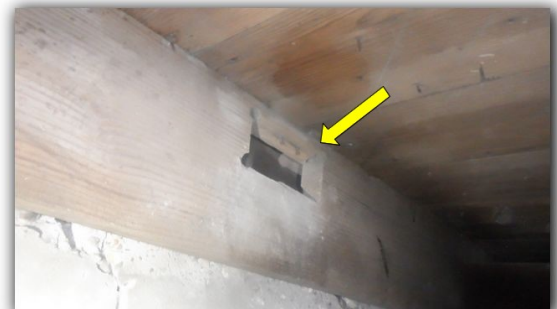
Observed floor joists improperly notched. Excessive notching limits the structural integrity of the joist. Including but not limited to the following locations; south middle edge

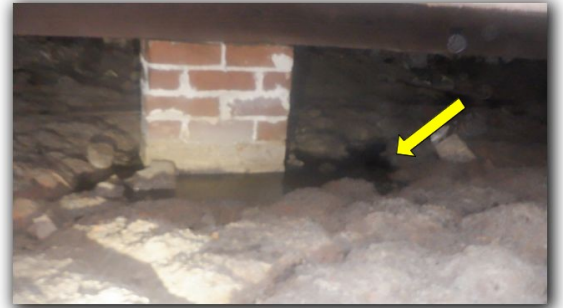
**Standing water observed below house; Due to improper site drainage and/or broken water/sewer line below house. This condition is detrimental to adequate foundation performance of pier and beam foundation systems and should be corrected. The Inspector does not crawl through standing water due to potential health hazards present.**

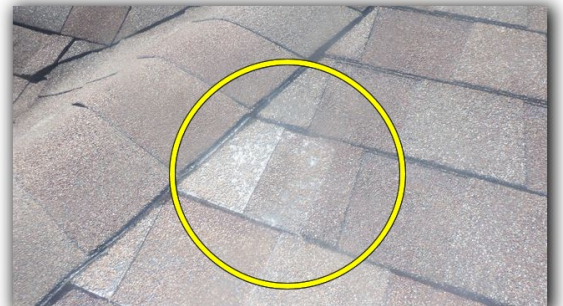
Roof manufacture defect observed at numerous locations on the west side of the roof structure.

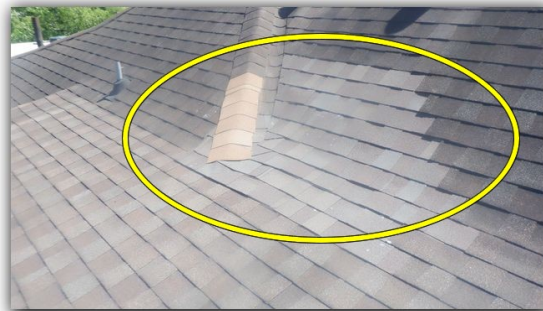
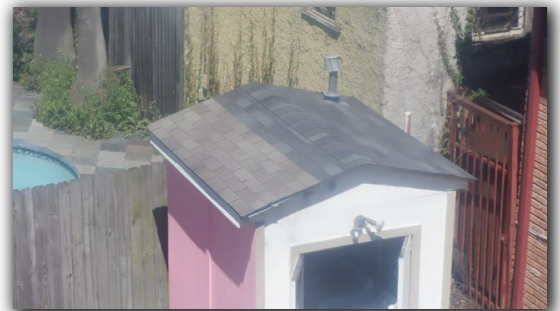
Observed spot repairs to roof surface.

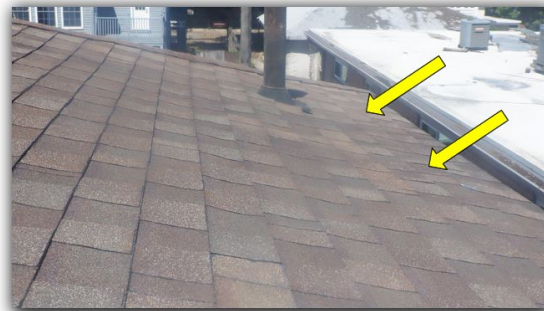
Sag(s) in roof decking observed. Probable cause is from improper/ inadequate framing in the attic.

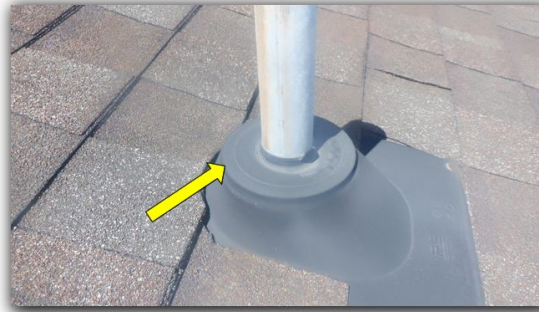
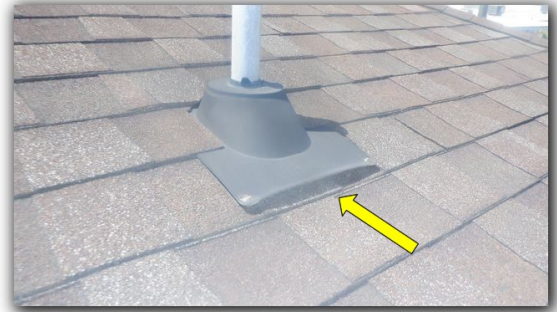
Rubber gasket of drain waste vent is inverted, may allow water entry.(northeast corner)  
Lower side of drain waste vent flashing is not sealed down, wind driven rains can cause water penetration.

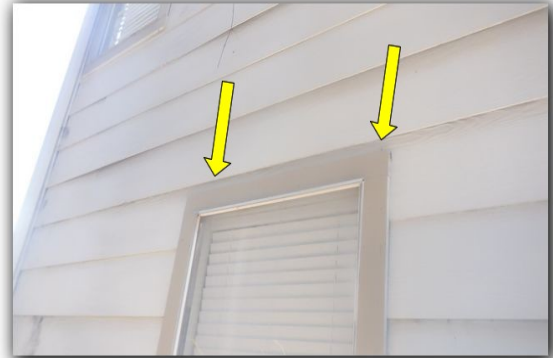
Head flashing missing over window/door trim pieces. Without head flashing over window trim, sealing must be maintained as a defense against water penetration.

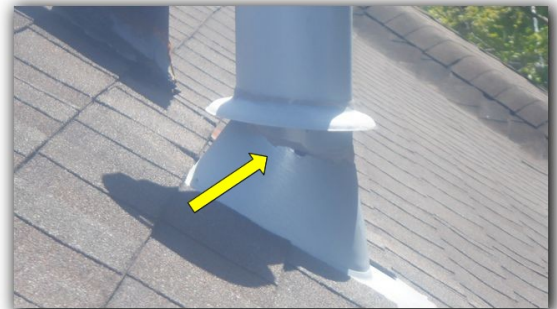
Storm collar not properly positioned on water and/or house heater vent pipe.  
Recommend sealing at all furnace vents vertical seams on the flue to help prevent moisture intrusion.

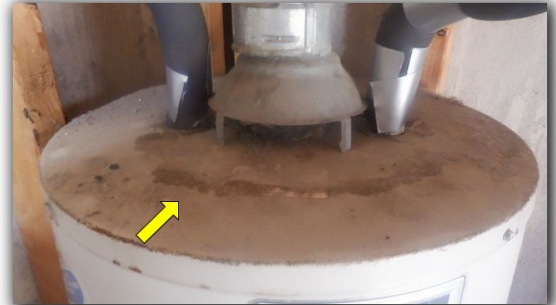
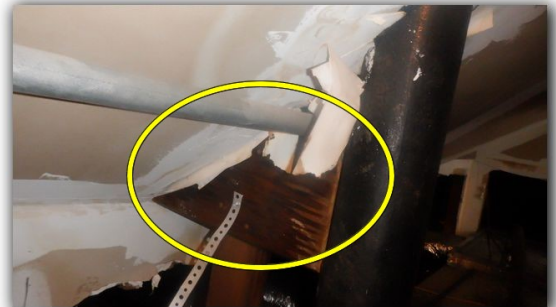
**Roof water penetration observed at the following location(s):evidence of water moisture intrusion observed in the attic on the north side, staining on a attic frame and higher than typical moisture meter readings were taken at the time of this inspection. Additional evidence of water penetration observed in the detached or laundry structure. This condition is due to the flue storm collar not being properly sealed.**

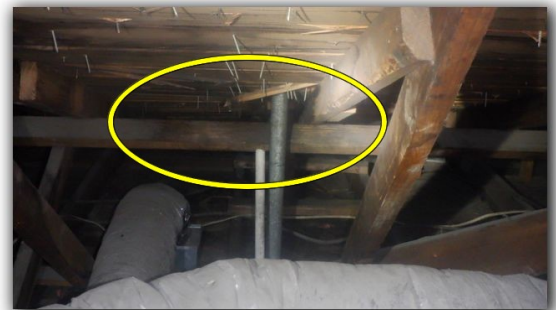
**Additional evidence of water intrusion observed in the attic at multiple locations.**

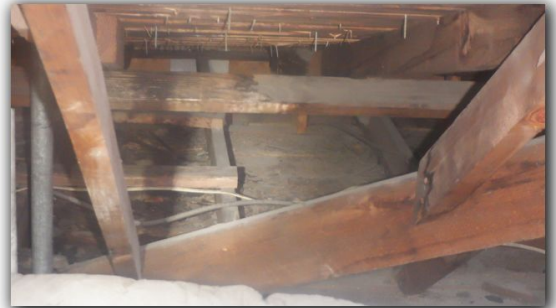
**Insulation not properly positioned/missing in areas, etc. (most of the insulation on the ceiling observed to be missing) Some of the ceiling insulation observed to be damaged or padded down by rodents and should be replaced for health reasons.**

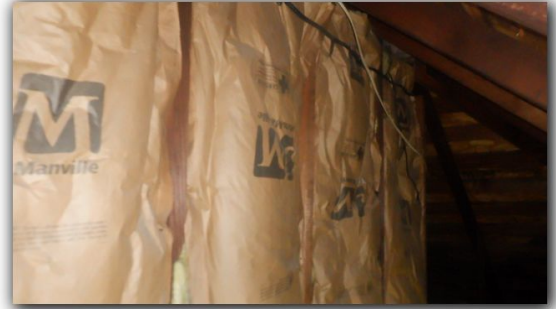
Insulation improperly installed. Vapor barrier not on “warm on winter” side.

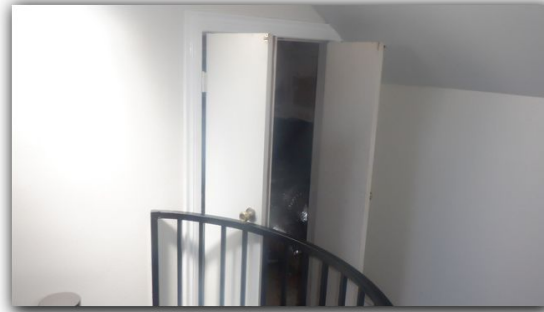
**All attic walk in doors should be self closing and self latching, fire rated, and weather stripped to help prevent the spread of potential carbon monoxide leak into the sleeping quarters and to slow down the spread of a fire should one occur in the attic due to 2 gas furnaces at this location.**

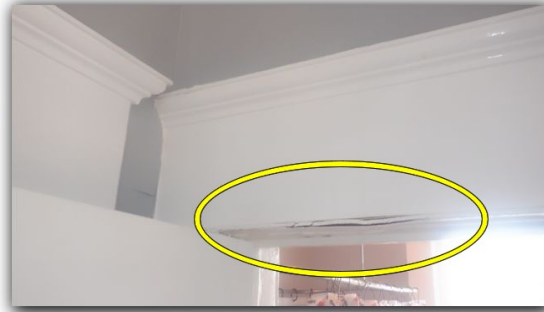
Wood deterioration to the bathroom door frame observed, condition appears to be due to previous roof or AC water leaks.

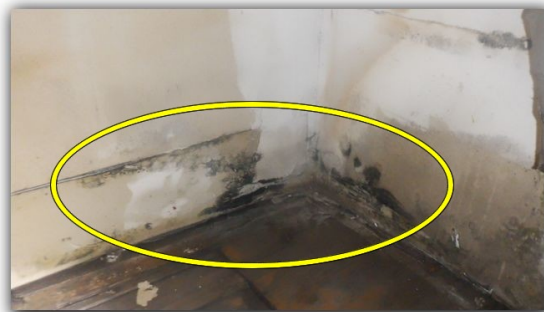
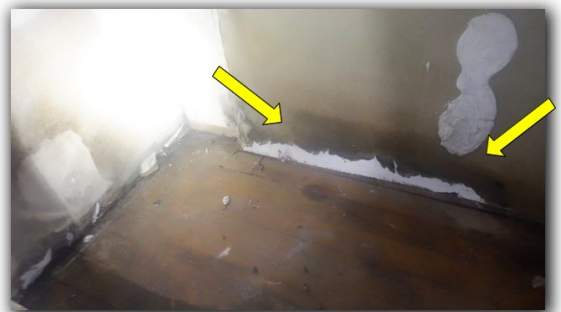
Observed possible micro-organism growth (return chase in units 3 and 4) which may be a concern due to increased awareness of environmental issues associated with molds. Recommend removal of all sheetrock containing visible mold growth plus an additional 2 feet surrounding area. This company does not inspect for and is not qualified to render opinions on any type on environmental or other bio-hazards. If this is a concern or potential concern, Sentinel Inspections recommends contacting a qualified professional of your choice for further information / investigation.

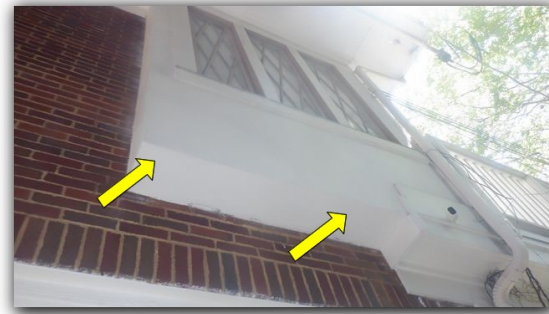
Did not observe weep screed at bottom of the stucco wall, where it intersects with the soffit. The following diagram depicts a “best practice” procedure as defined in the Texas Lathing and Plastering Contractor's Association (TLPCA) Stucco Resource Guide. This detail provide a means for moisture to exit from behind the stucco if the wall assembly leaks (we seldom see a weep screed at these locations on most stucco homes / buildings). If this exhibits a problem with moisture collecting in this area, a weep screed should be installed.

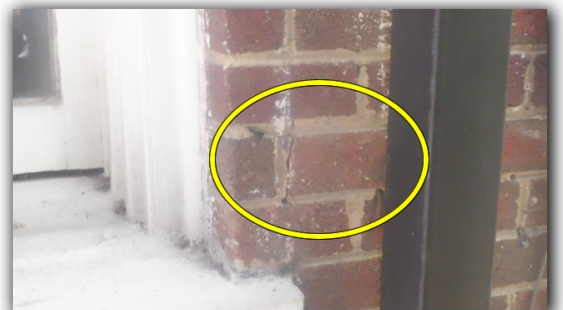
Cracks in brick veneer and/or repairs, one or more locations, Recommend buyer take photographs of cracks, their location, and width [ruler across the crack] with a high resolution camera that has a date stamp for future reference.

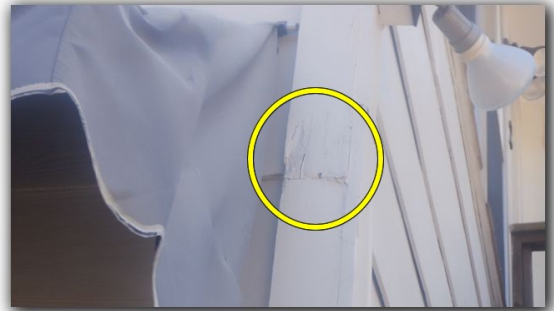
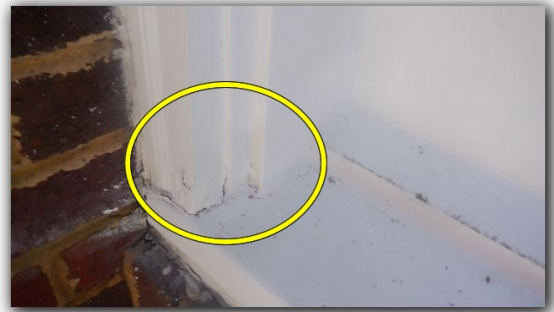
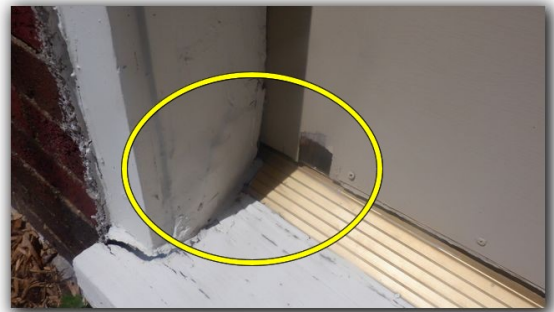
Wood rot observed on areas of house / garage.

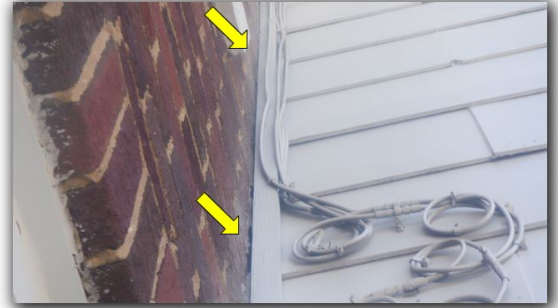
Caulking missing and/or deficient around vertical trim boards may allow wind driven rain entry.

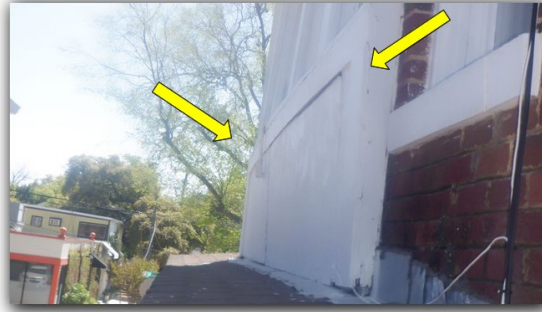
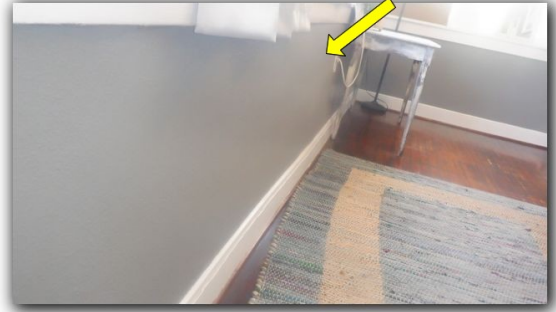
The east 2nd floor wall observed to be bowing out and veneer not sealed. This condition could be due to framing damage, foundation settlement or inadequate framing. The cause and remedy should be investigated and corrected as necessary.

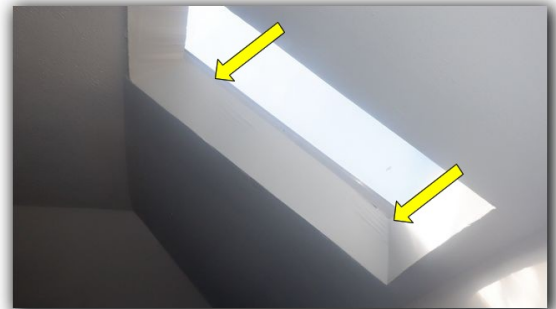
Water stains / damage or repairs observed; by skylight on unit 2. Wood deterioration to the interior framing also observed. This condition should be closely monitored and repaired as necessary.

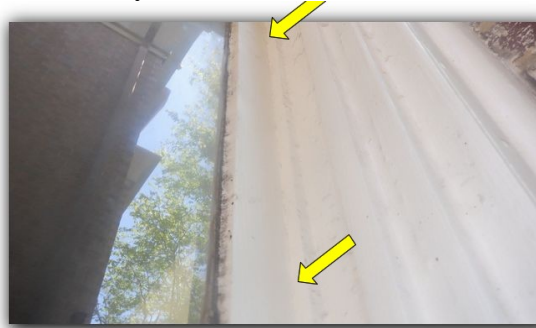
Buyer's note; Many were not operational, **painted shut**, ropes broken, etc.. windows in a bedroom that do not open are a recognized fire/safety hazard.

Buyer's note; observed bedroom(s) without operational / operable window and/or 2<sup>nd</sup> means of emergency egress is a **RECOGNIZED FIRE/SAFETY HAZARD**. Does not comply current life safety codes. Room should not be used as a sleeping area.

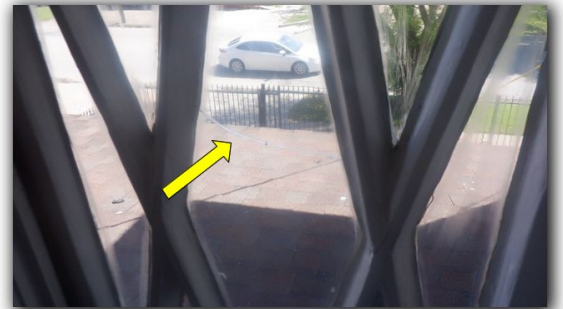
One or more windows had cracked / broken glass pane(s).(unit 4)

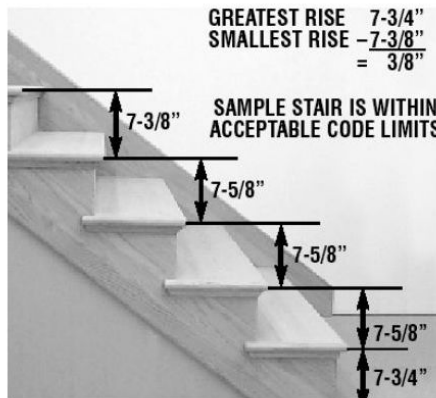
Stairway has tripping hazard, Risers are not same height along the entire height of steps. Stairway does not comply with current industry standard, (code). CABO 314.2 & UBC 1006.3 requires "The greatest riser height within any flight of stairs shall not exceed the smallest by more than 3/8 inch."

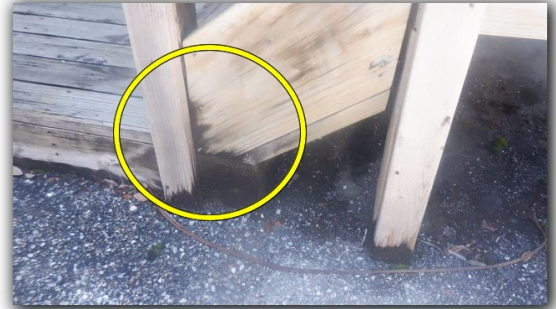
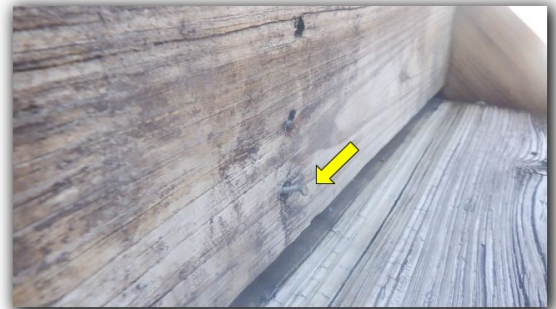
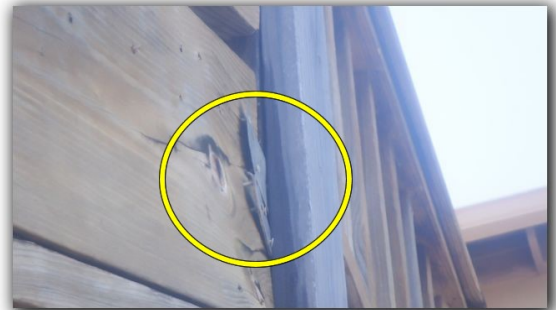
**It is the inspector's opinion that the exterior stairs case is in poor condition. Base support columns observed to be deteriorated, some of the threads are deteriorated, nails or fasteners observed to be pulling loose, guard rails observed to be loose and connector plate fasteners observed to be pulling loose.**

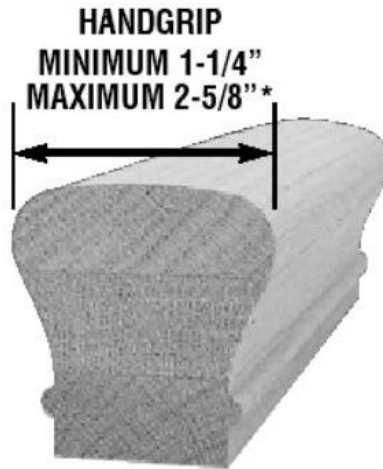
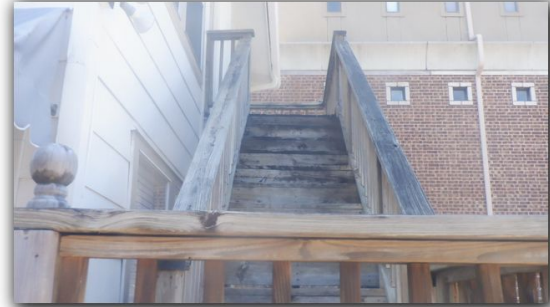
Section of gripable (proper size) handrail missing; Reference IRC R315.2 “the handgrip portion of handrails shall have a circular cross section of 1 ¼ inches minimum to 2 5/8 inches maximum.”

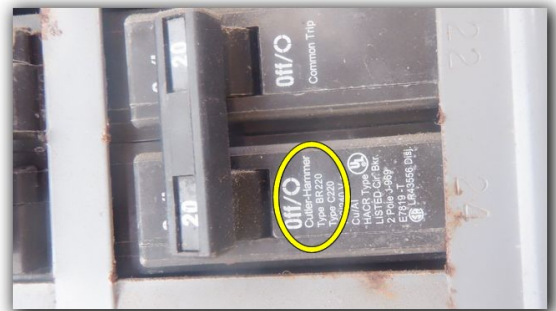
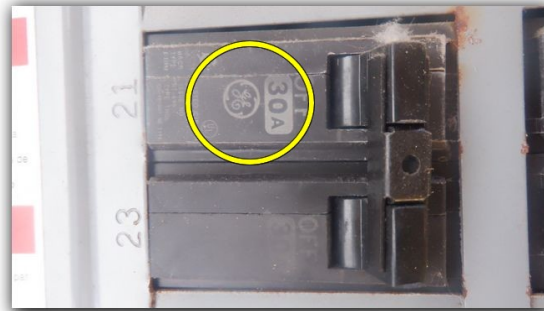
Incorrect type (wrong brand) of breaker observed in service panel.(PANEL BOX 3). The Square D box improperly has a Cutler Hammer and A GE breaker at the base of the box.

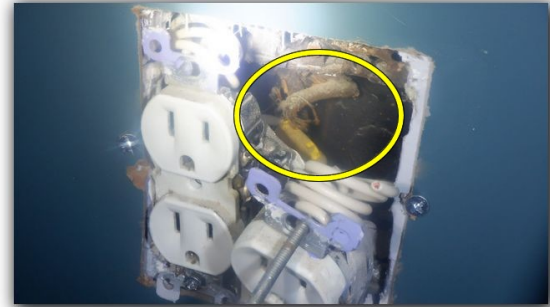
**Observed type of branch wiring is a mix of Romex and antiquated Knob & tube. Be advised most insurance companies do not insure a building with Knob & Tube wiring or may charge a higher rate due to fact that Knob & Tube wiring is considered antiquated by today's standards. Client should contact prospective insurer to find out if coverage is provided as well as contacting qualified electrician regarding updating electrical system to meet minimum / code standards.**

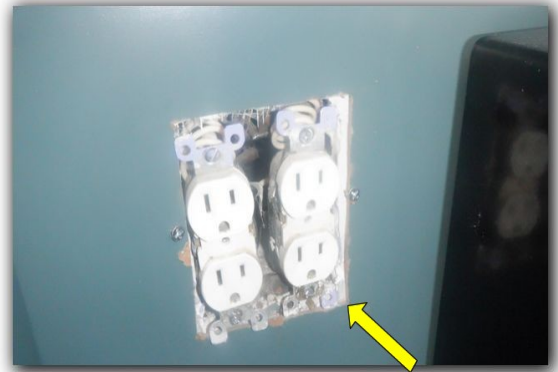
Outlets / switches / devices installed in / through combustible material were not flush mounted as required by code, space exists between face plate and edge of electrical junction box. Missing required spacer ( spark ring) on following outlet(s): kitchen area of unit 2 Reference NEC 370-20 & IRC E3806.5. In walls constructed of wood or other combustible material, cabinets (outlet & switch boxes) shall be flush with the finished surface or shall project there-from.

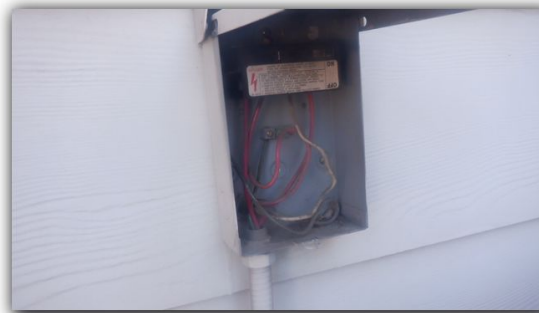
Service panel or disconnect dead front is missing or not in place, exposing live electrical wiring, shock hazard.(unit 2)

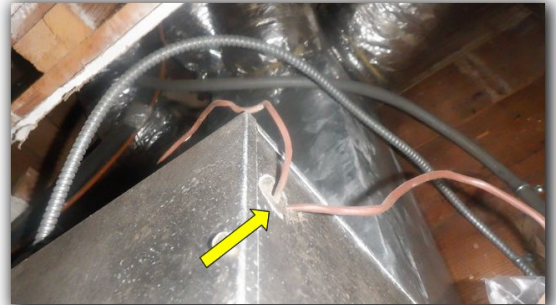
Thermostat wiring not secured to attic unit(s), missing small fitting that secures wiring to cabinet to prevent pulling loose by service personnel or homeowner.

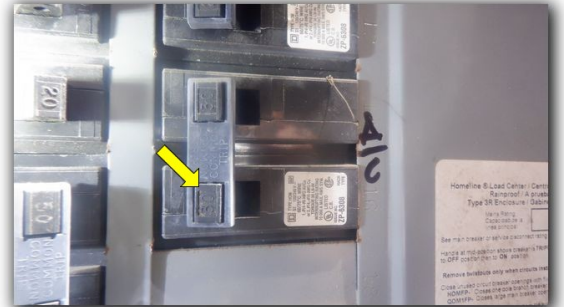
Improper sizing of breaker to unit may void manufacture's warranty. Data plate on unit states maximum breaker size to be 20 amps, observed size in service panel is 30 amps.

**Recommend qualified/licensed HVAC technician service/repair/replace as needed. Not cooling well.**

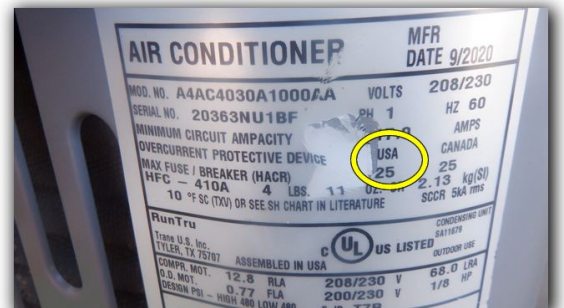
Improper sizing of breaker to unit may void manufacture's warranty. Data plate on unit states maximum breaker size to be 25 amps, observed size in service panel is 30 amps.

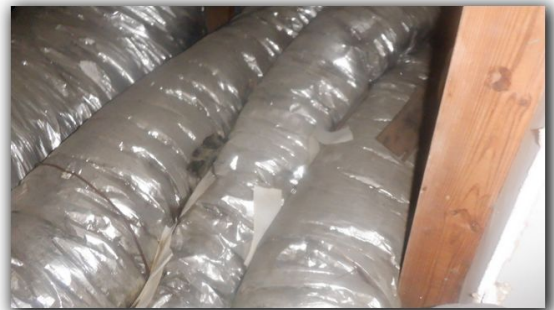
Observed several / multiple areas in attic where flex duct touch and are missing required 1" clearance from other ducts to prevent condensation between ducts that touch.

Recommend general maintenance to flex ducts in attic. Re-support where needed, seal/tape minor air leaks, repair torn/damaged vapor seal, etc.

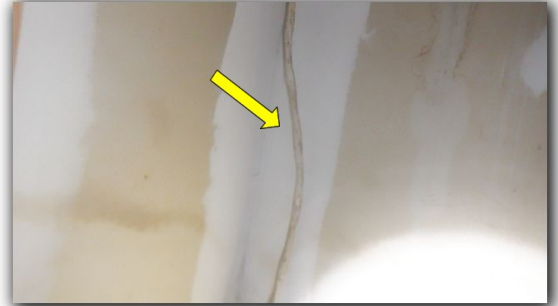
120 Volt electrical wiring improperly located in return air chase. Does not comply with current industry standard/code. Ref. NEC 300-22(c).(units 3 and 4)

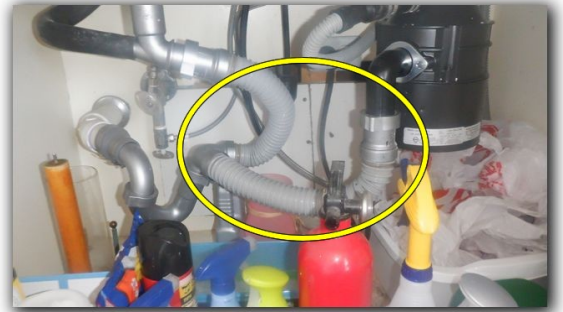
Amateurish plumbing observed; under the kitchen sink at unit 2.

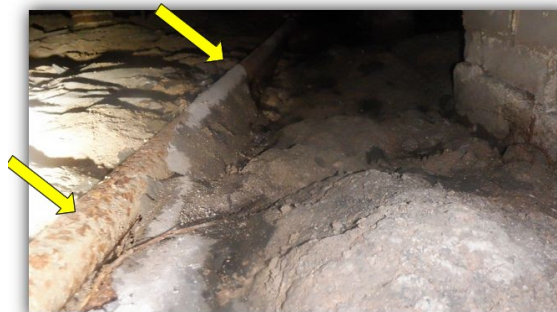
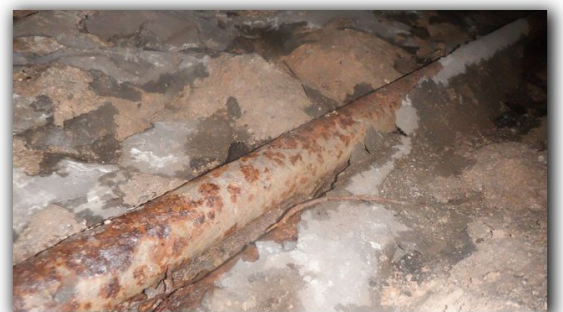
**A main drain under the structure observed to be excessively corroded and appears to be leaking. The remedy should be investigated and corrected as necessary.**

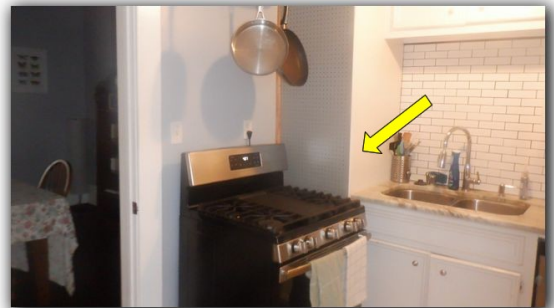
**The downstairs water heaters were not accessible. The units are located to the side of the range/oven and mechanically sealed with a panel. The 2 water heaters could not be inspected. Age size and condition were unknown.**

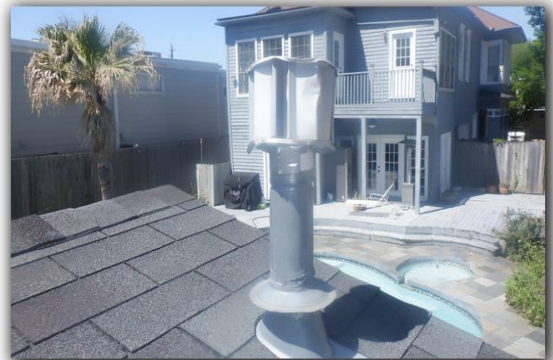
Improperly vented, does not extend high enough above roof. Vent pipe is required to extend and terminate at least 24 inches above roof line to the lowest discharge opening of the vent cap. (Ref: IRC 2004 Section 2427.6.5 Gas Vent Termination)(laundry water heater)

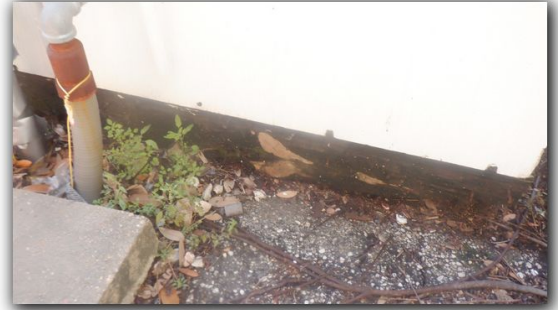
**The outdoor laundry structure in poor condition, leaning, and foundation was rotted. This condition could lead to damage to the plumbing connected to the washing machine and water heater.**
