**SENTINEL**  
INSPECTION GROUP

# PROPERTY INSPECTION REPORT FORM

Keesha Johnson <i>Name of Client</i>	03/22/2024 <i>Date of Inspection</i>
324 W Alabama St., Houston 77006 <i>Address of Inspected Property</i>	
Ruben Santillan <i>Name of Inspector</i>	5570 <i>TREC License #</i>
<i>Name of Sponsor (if applicable)</i>	<i>TREC License #</i>

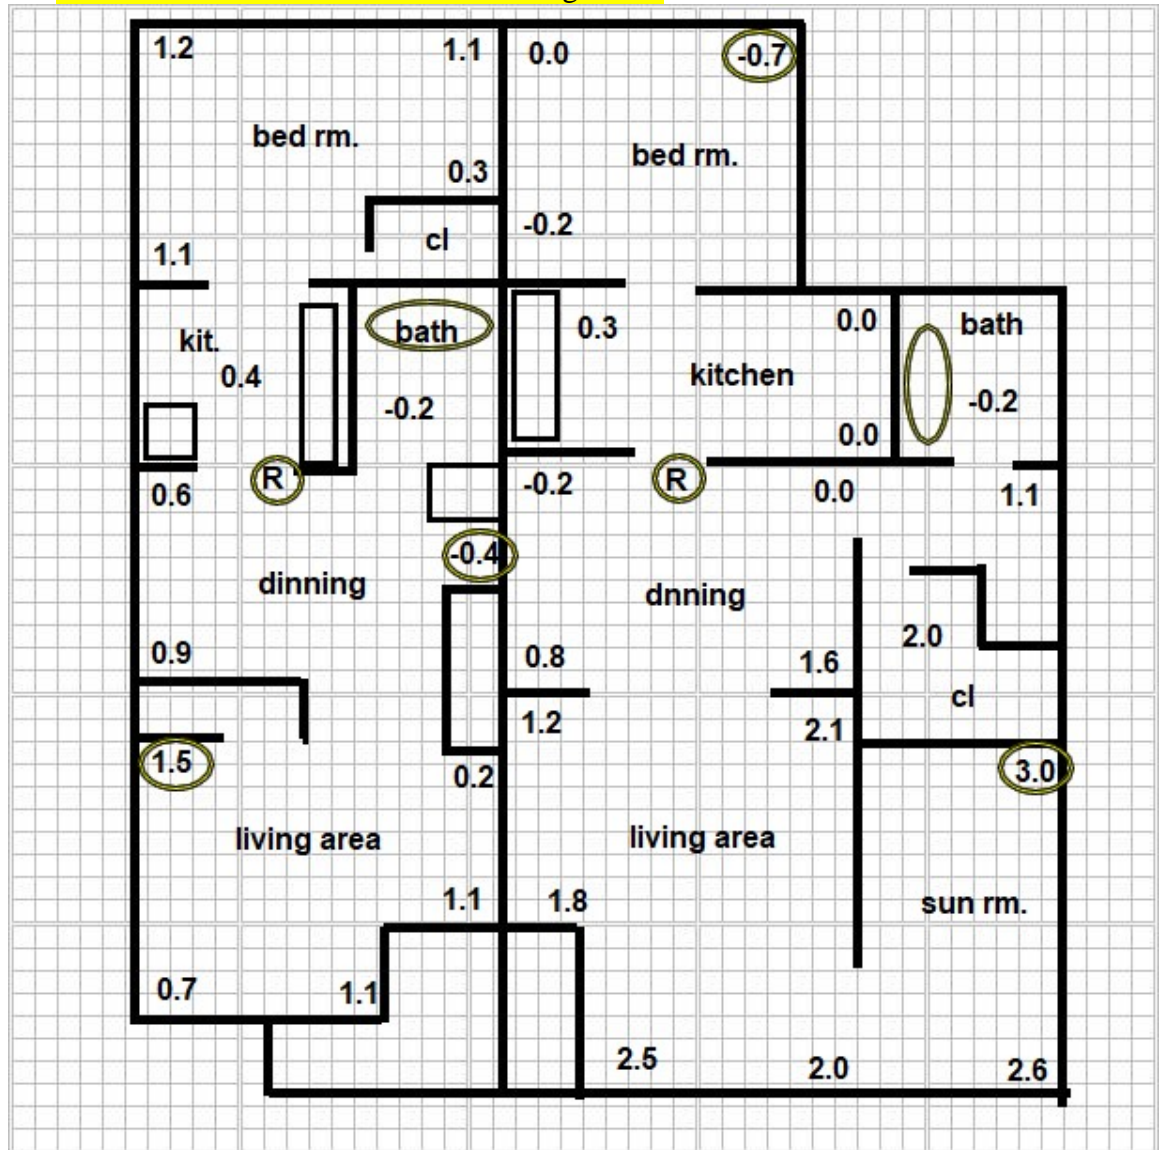
A foundation elevation survey was conducted during the inspection. The table below represents data gathered using a Zip Level or similar instrument and adjusting for floor covering height differences. i.e. differences between tile, carpet and wood flooring. Measurements are listed to the nearest .1". Measurements were taken along the respective walls listed below-North, East South, West, etc. Greatest variance was 1.9 inches for left side and 3.7 for the right side

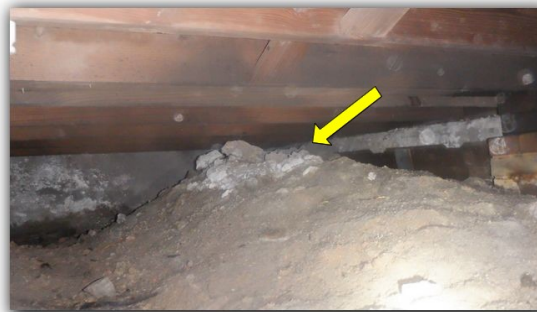
Observed wood framing under house has inadequate clearance from soil to prevent wood rot according to code. **Minimum soil clearance to untreated wood joists is 18".** **Minimum soil clearance to untreated wood beams is 12".** IRC R317.1

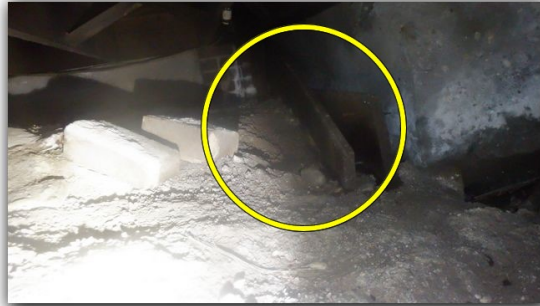
Scrap wood below house is considered a conducive condition for wood destroying insects.

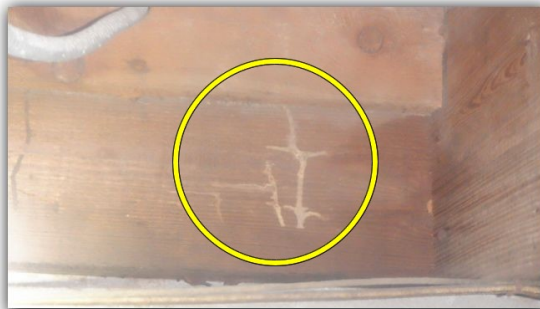
Multiple areas observed below house with various degrees of damage from wood destroying insects. No damage found was significant enough in my opinion as in need of repair.

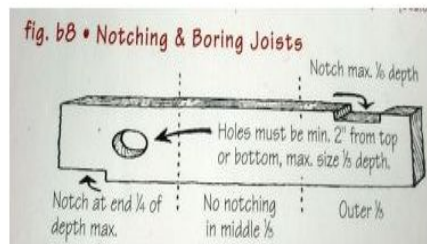
Observed floor joists improperly notched. Excessive notching limits the structural integrity of the joist. Including but not limited to the following locations; south middle edge

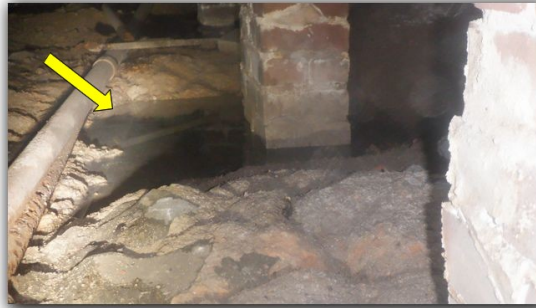
**Standing water observed below house; Due to improper site drainage and/or broken water/sewer line below house. This condition is detrimental to adequate foundation performance of pier and beam foundation systems and should be corrected. The Inspector does not crawl through standing water due to potential health hazards present.**

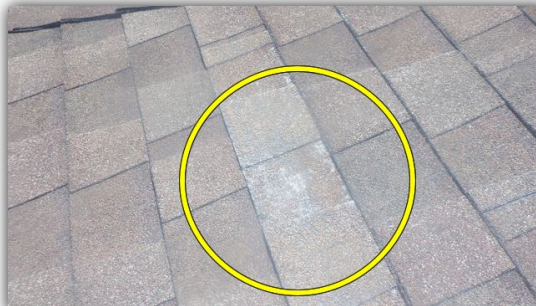
Roof manufacture defect observed at numerous locations on the west side of the roof structure.

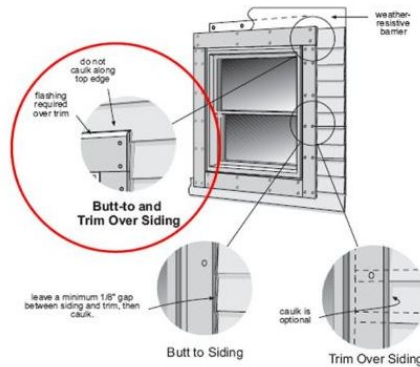
Head flashing missing over window/door trim pieces. Without head flashing over window trim, sealing must be maintained as a defense against water penetration.

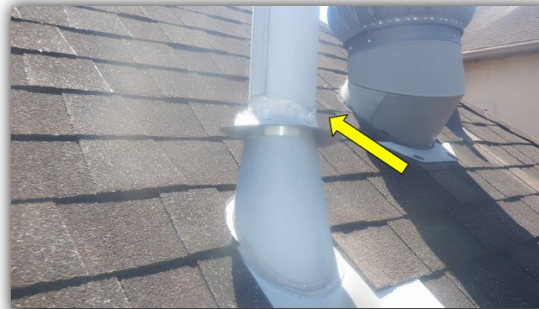
Storm collar not properly positioned on water and/or house heater vent pipe.  
Recommend sealing at all furnace vents vertical seams on the flue to help prevent moisture intrusion.

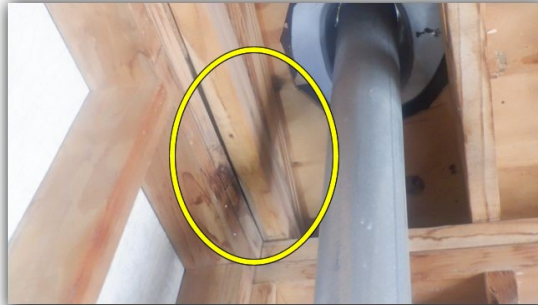
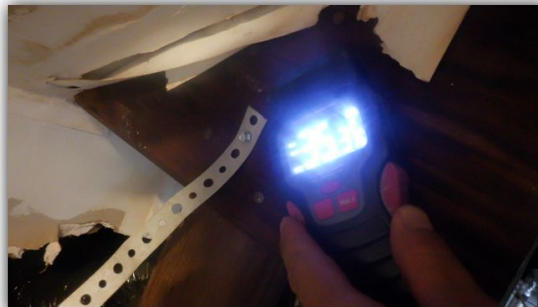
**Roof water penetration observed at the following location(s):evidence of water moisture intrusion observed in the attic on the north side, staining on a attic frame and higher than typical moisture meter readings were taken at the time of this inspection. Additional evidence of water penetration observed in the detached or laundry structure. This condition is due to the flue storm collar not being properly sealed.**

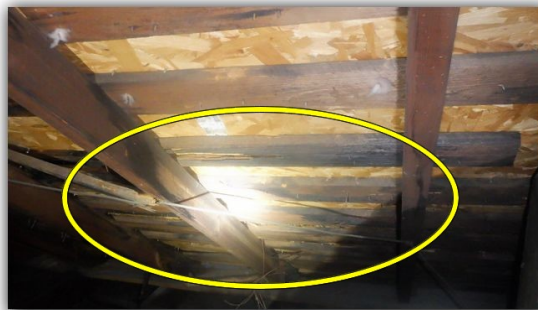
**Additional evidence of water intrusion observed in the attic at multiple locations.**

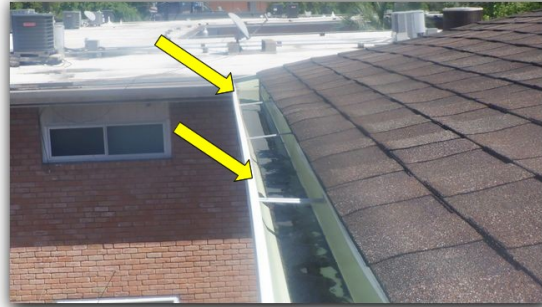
Downspouts need splash blocks at bottoms to prevent soil erosion.  
Section(s) of gutters observed holding standing water. The gutter does not appear to be properly sloped toward the downspout.

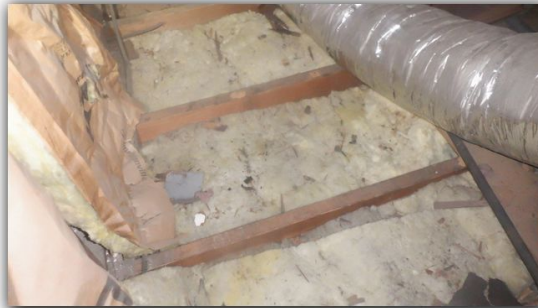
**Insulation not properly positioned/missing in areas, etc. (most of the insulation on the ceiling observed to be missing) Some of the ceiling insulation observed to be damaged or padded down by rodents and should be replaced for health reasons.**

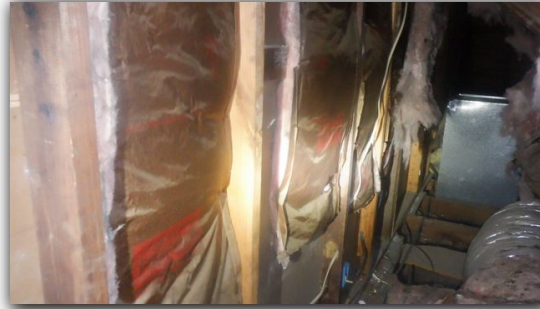
Insulation improperly installed. Vapor barrier not on “warm on winter” side.

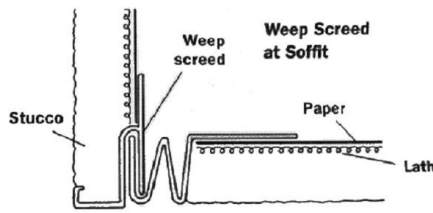
Did not observe weep screed at bottom of the stucco wall, where it intersects with the soffit. The following diagram depicts a “best practice” procedure as defined in the Texas Lathing and Plastering Contractor's Association (TLPCA) Stucco Resource Guide. This detail provide a means for moisture to exit from behind the stucco if the wall assembly leaks (we seldom see a weep screed at these locations on most stucco homes / buildings). If this exhibits a problem with moisture collecting in this area, a weep screed should be installed.

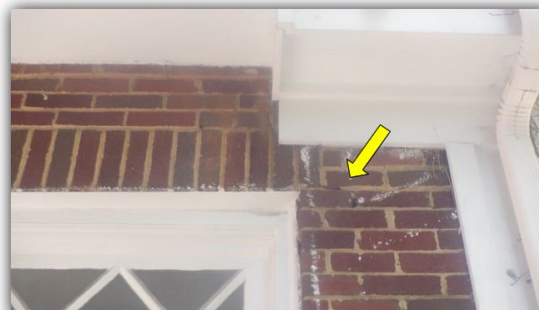
Cracks in brick veneer and/or repairs, one or more locations, Recommend buyer take photographs of cracks, their location, and width [ruler across the crack] with a high resolution camera that has a date stamp for future reference.

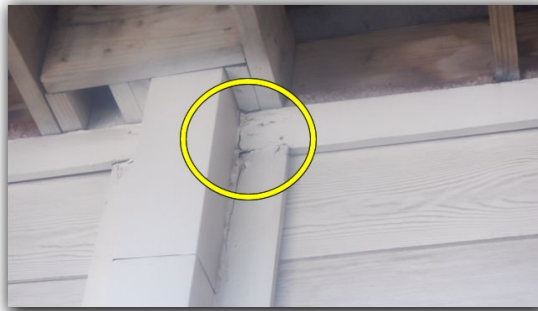
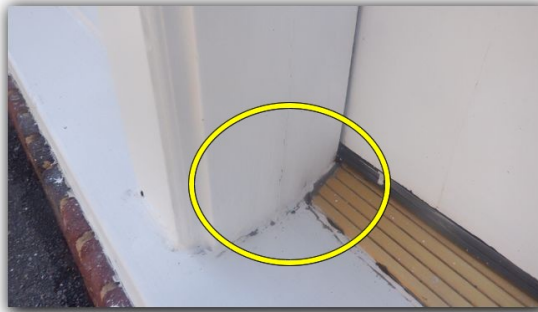
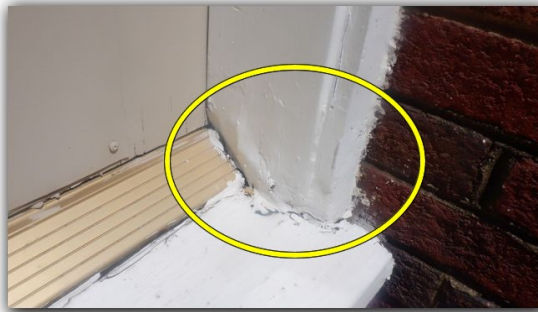
Wood rot observed on areas of house / garage.

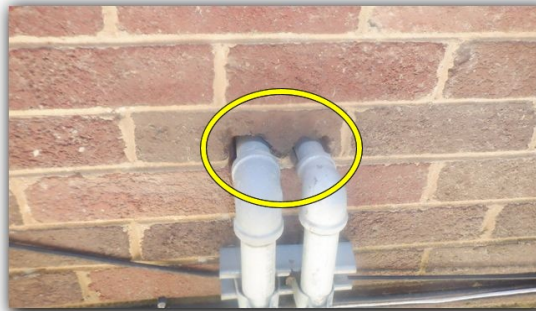
Need sealing / caulking around all holes and exterior siding penetrations on top and both sides, (leave bottom open) to prevent water entry. Including but not limited to dryer, bath and range top vents, light fixtures, etc.

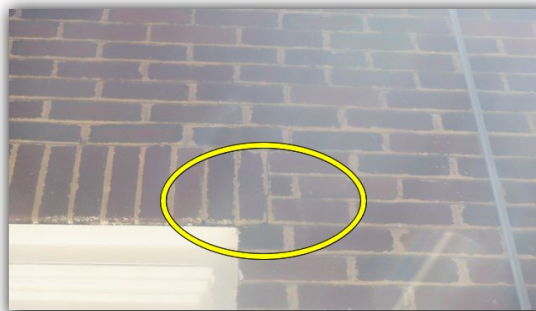
*Cracks at upper corners of windows is typical due to not enough space left at ends of steel lintel at time of construction to allow for expansion of metal.*

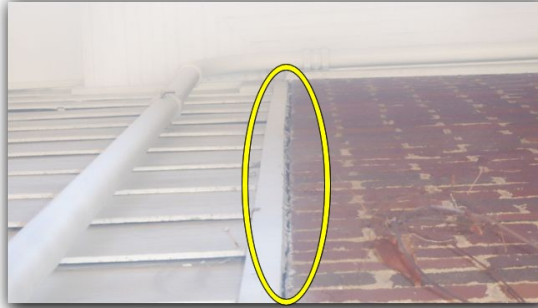
Caulking missing and/or deficient around vertical trim boards may allow wind driven rain entry.

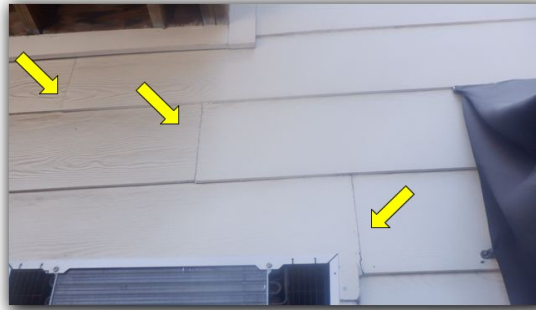
Recommend sealing veneer vertical joints to help prevent possible moisture penetration at one or more locations.

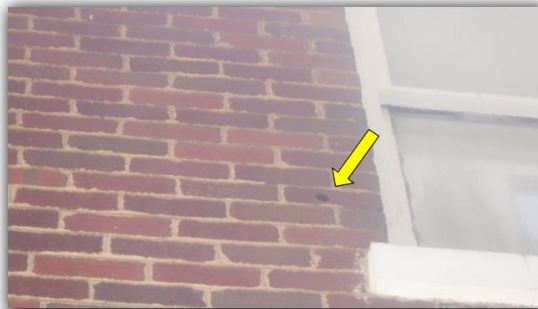
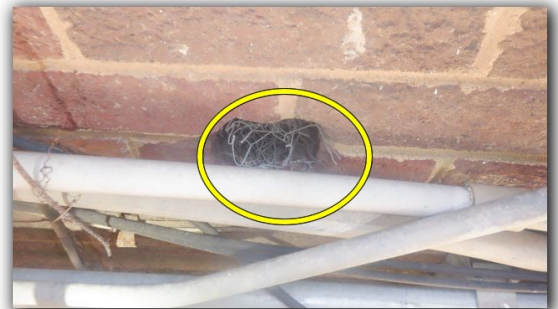
Brick voids on the west side of the structure should be sealed to help prevent water intrusion.

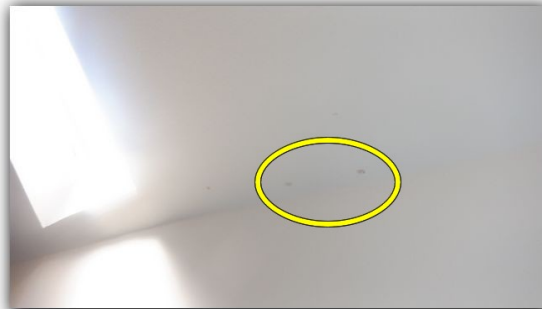
Water stains / damage or repairs observed; by skylight on unit 2. Wood deterioration to the interior framing also observed. This condition should be closely monitored and repaired as necessary.

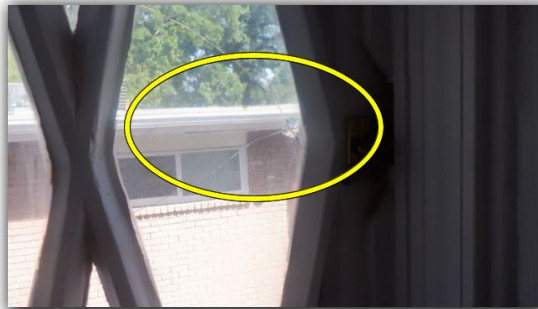
One or more windows had cracked / broken glass pane(s).(unit 4)

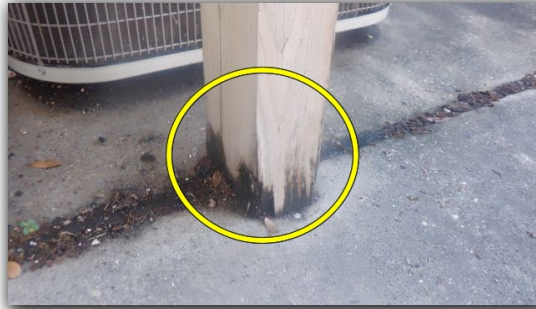
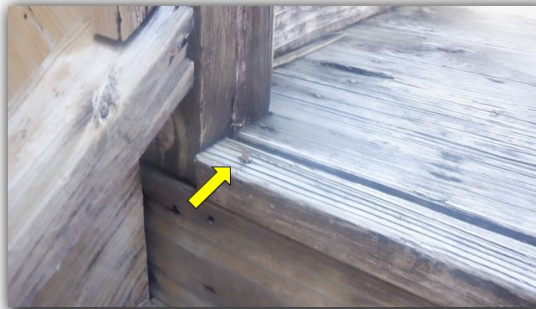
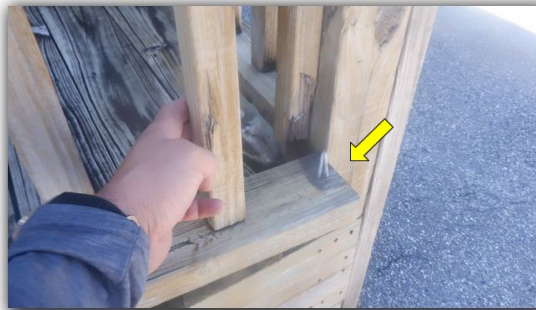
**It is the inspector's opinion that the exterior stairs case is in poor condition. Base support columns observed to be deteriorated, some of the threads are deteriorated, nails or fasteners observed to be pulling loose, guard rails observed to be loose and connector plate fasteners observed to be pulling loose.**

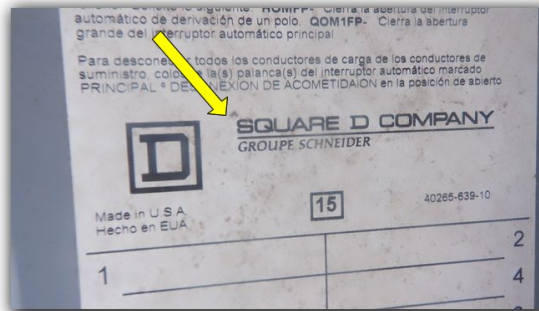
Incorrect type (wrong brand) of breaker observed in service panel.(PANEL BOX 3). The Square D box improperly has a Cutler Hammer and A GE breaker at the base of the box.

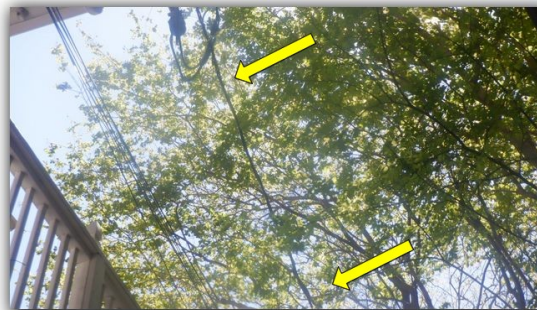
Tree limbs in contact with electrical lines to house. Recommend Centerpoint or professional tree trimmer be contacted for this corrective action because of risk of injury / electrocution.

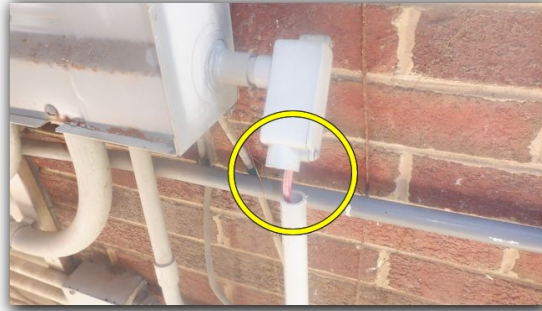
Electrical conduit not secured in place, adjacent to panel box #1 on the west exterior.

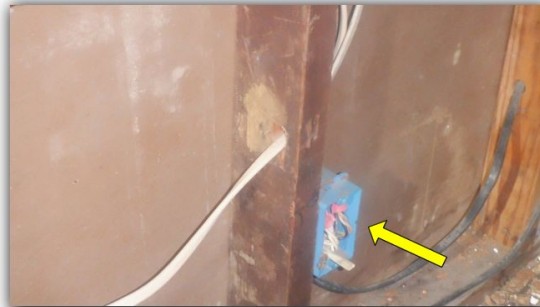
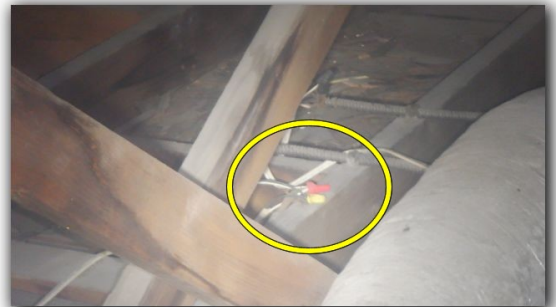
Wire connections are not enclosed in proper electrical junction box(s), or electrical junction box(s) do not have covers in place, including but not limited to the following location; west and northeast sections of the attic.

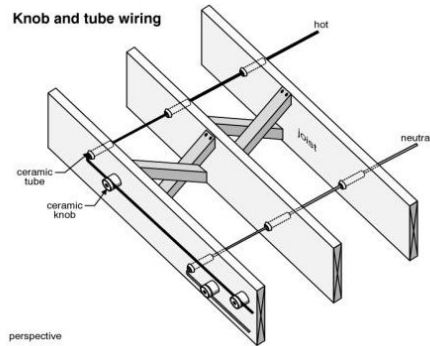
**Observed type of branch wiring is a mix of Romex and antiquated Knob & tube. Be advised most insurance companies do not insure a building with Knob & Tube wiring or may charge a higher rate due to fact that Knob & Tube wiring is considered antiquated by today's standards. Client should contact prospective insurer to find out if coverage is provided as well as contacting qualified electrician regarding updating electrical system to meet minimum / code standards.**

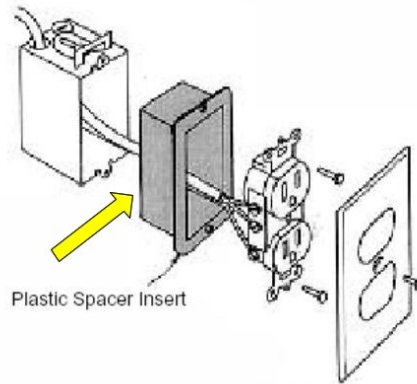
Outlets / switches / devices installed in / through combustible material were not flush mounted as required by code, space exists between face plate and edge of electrical junction box. Missing required spacer ( spark ring) on following outlet(s): kitchen area of unit 2 Reference NEC 370-20 & IRC E3806.5. In walls constructed of wood or other combustible material, cabinets (outlet & switch boxes) shall be flush with the finished surface or shall project there-from.

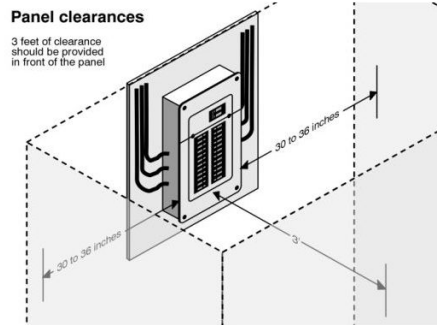
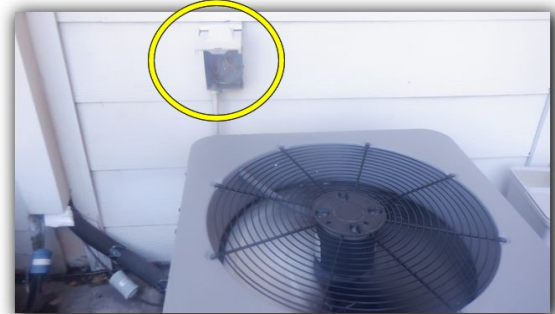
Code requires minimum clearance to electrical service panels (including A/C disconnects) to be 36" in front of and 30" from side to side.

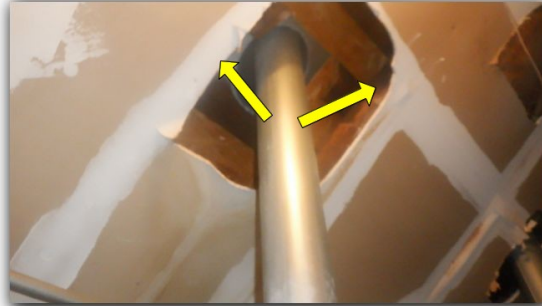
Vent pipe(s) is (are) not properly secured (strapped) in placed.(unit 1)

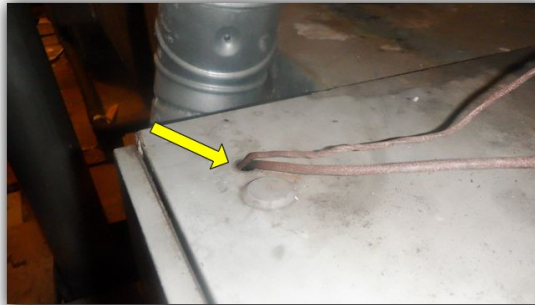
Thermostat wiring not secured to attic unit(s), missing small fitting that secures wiring to cabinet to prevent pulling loose by service personnel or homeowner.

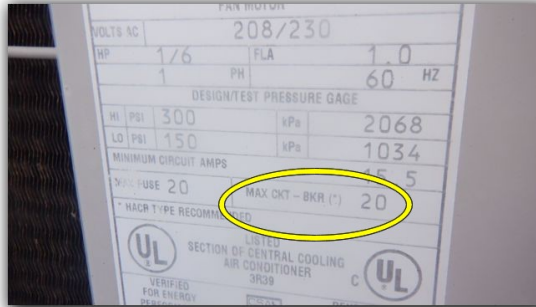
Improper sizing of breaker to unit may void manufacture's warranty. Data plate on unit states maximum breaker size to be 20 amps, observed size in service panel is 30 amps.

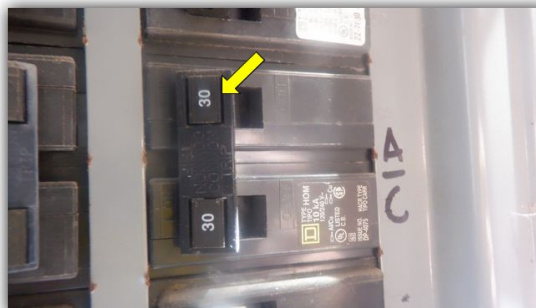
Improper sizing of breaker to unit may void manufacture's warranty. Data plate on unit states maximum breaker size to be 25 amps, observed size in service panel is 30 amps.

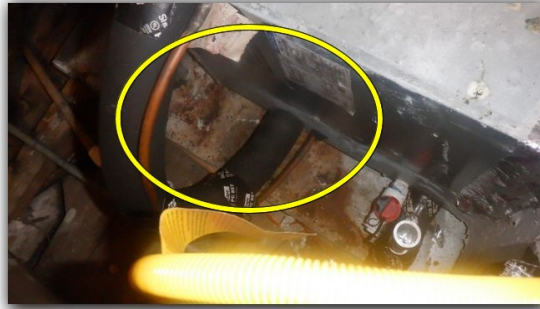
*Secondary drain pan is rusted; indication coil (or previous coil) has history of leaking/dripping condensation into pan. (unit 1)*

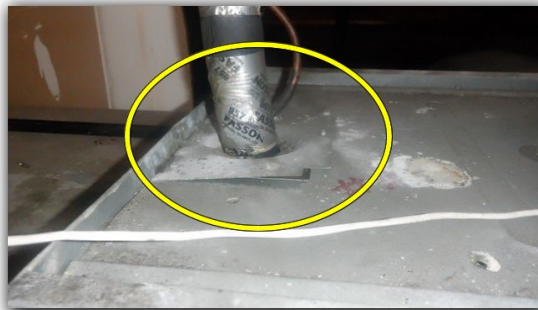
Observed several / multiple areas in attic where flex duct touch and are missing required 1" clearance from other ducts to prevent condensation between ducts that touch.

Recommend general maintenance to flex ducts in attic. Re-support where needed, seal/tape minor air leaks, repair torn/damaged vapor seal, etc.

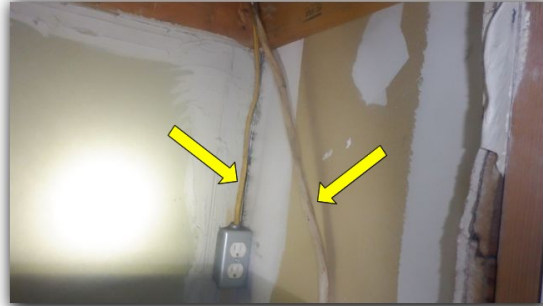
120 Volt electrical wiring improperly located in return air chase. Does not comply with current industry standard/code. Ref. NEC 300-22(c).(units 3 and 4)

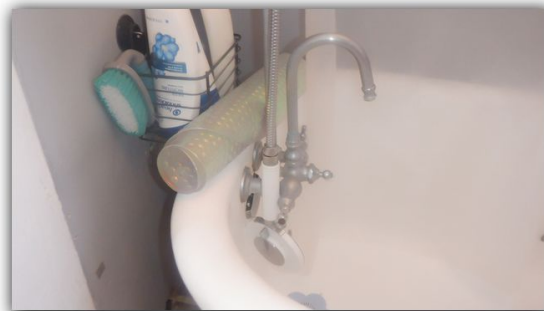
Cross connection present on old bath tub. Spigot located below flood level rim of tub which can create a cross connection if tub is filled above spigot level.(all of the bathtubs)

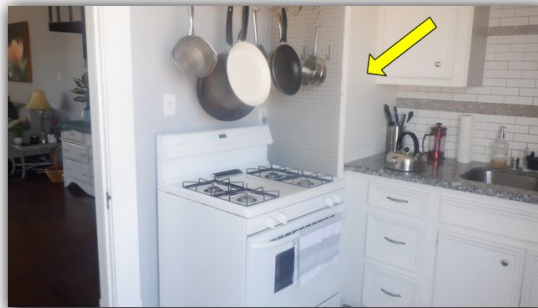
**The downstairs water heaters were not accessible. The units are located to the side of the range/oven and mechanically sealed with a panel. The 2 water heaters could not be inspected. Age size and condition were unknown.**

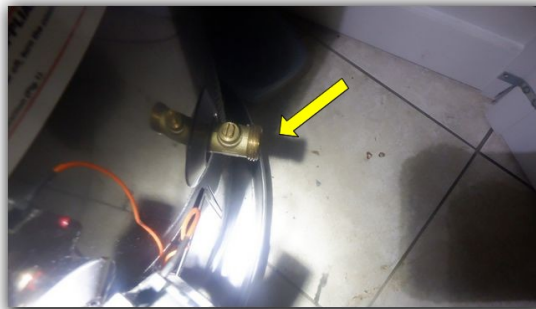
Lower drain valve extends over drain pan, should valve leak, water will not be contained in drain pan REF.: 1991 Standard Plumbing Code 1213.7.2(unit 1)

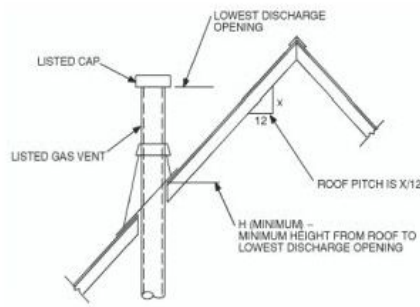
Improperly vented, does not extend high enough above roof. Vent pipe is required to extend and terminate at least 24 inches above roof line to the lowest discharge opening of the vent cap. (Ref: IRC 2004 Section 2427.6.5 Gas Vent Termination)(laundry water heater)

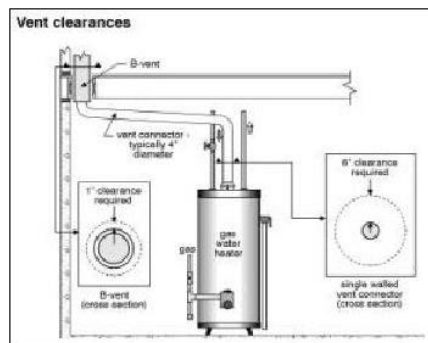
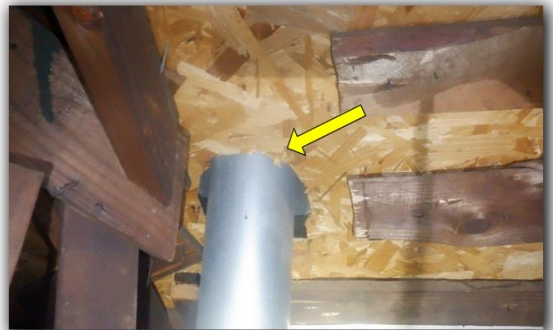
Vent pipe(s) is (are) not properly secured (strapped) in place.(laundry water heater, and west attic)

Exhaust vent pipe is in contact or does not have required minimum 1" clearance from combustible material, [wood roof decking].(west side of attic)

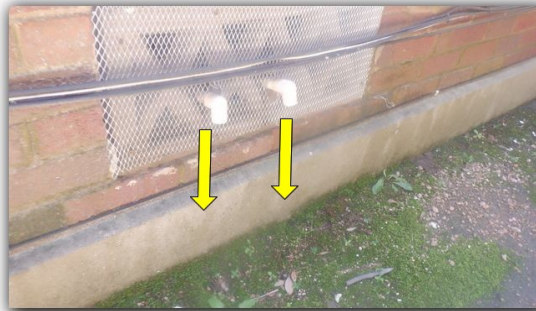
Drain line terminates improperly, current industry standards (Code) require drain line terminate within 6 inches from grade. Recognized safety hazard, repair IRC 2803.6.1.

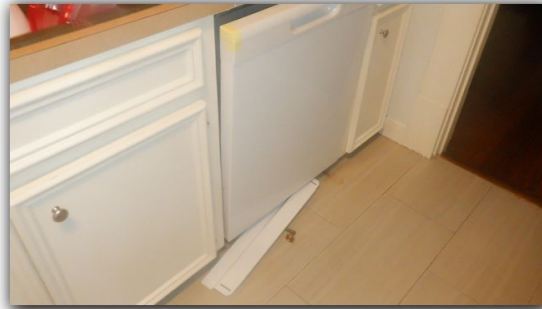
The dishwasher for unit 3 was not functioning at the time of this inspection. Under repairs.

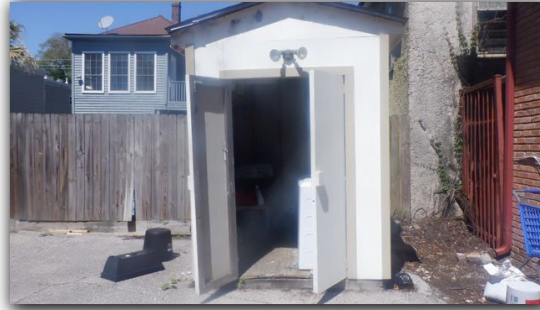
**The outdoor laundry structure in poor condition, leaning, and foundation was rotted. This condition could lead to damage to the plumbing connected to the washing machine and water heater.**
